# 城市山地保护：美国俄亥俄州辛辛那提市案例研究

## Urban Hillside Protection: A Case Study of Cincinnati, Ohio, United States of America

著：（美）埃里克·鲁索 （美）蒂姆·阿格内洛 译：张文正 胡一可 校：李正

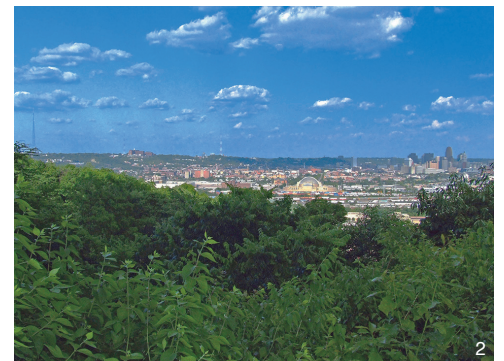
2 从普莱斯山向东远眺辛辛那提市的盆地。注意那些环绕盆地背景的山坡，其形成一条几乎相同的地平线

View of Cincinnati basin looking east from Price Hill. Note hillsides in the background that encircle the basin and form a nearly uniform horizon line

辛辛那提核心区域（或市中心）通常被称为盆地（图1），三面为高出盆底70多m的陡坡（图2）。一些次级山谷——包括那些属于米尔溪和鹿溪流域的山谷——分别从西部和东部切割盆地山坡，其他次级山谷则直接切入俄亥俄河谷。这些山谷在通往高地的路上形成更小和更浅的沟谷，在盆地上方形成一条连续的地平线。

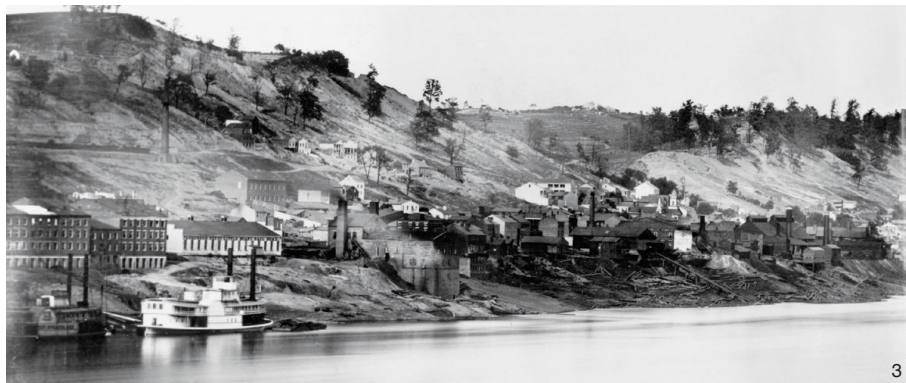
3 1848 年亚当斯山的毁林区域（7 号底片）。俄亥俄河位于前景

Deforested hillsides - Mt. Adams, 1848 (Plate No. 7). Ohio River is in the foreground

人口的迅速增长导致对自然资源特别是木材的需求增加。著名医生及自然主义者丹尼尔·德雷克于1815年指出，木材是“主要燃料且来自周围山丘”<sup>[7]</sup>。此外山地还被用于农业生产，被犁耕以种植农作物，以及被开垦为梯田以种植葡萄<sup>[8]</sup>。19世纪辛辛那提的山坡上普遍进行放牧活动<sup>[9]</sup>，这可能是造成植被破坏、梯田形成和水土流失加剧的一个因素。辛辛那提和汉密尔顿公共图书馆的主要分馆收藏了由丰泰纳和波特拍摄于19世纪中期的一系列全景式银版照片，这些照片描绘了辛辛那提山地植被遭到改变和伐毁的场景（图3）。

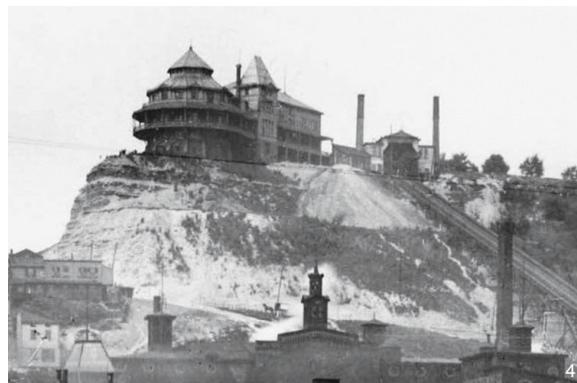
4 1900 年前后的贝尔维尤住宅及斜坡（克利夫顿）。注意建筑群下面的因采石活动而形成的高耸悬崖

Bellevue House and incline (Clifton) circa 1900. Note the high vertical cliffs below the complex from quarrying activity

采石是严重影响山地的另一个产业。石灰石是建筑、地基和挡土墙的首选建材<sup>[10]</sup>，也是石灰砂浆、路基和路面的重要材料<sup>[11-12]</sup>。除了河床采石场，山地采石场是辛辛那提石灰岩的另一个主要来源<sup>[11-12]</sup>。山地采石场的最理想位置是费尔维尤组上部50英尺（约15m）处<sup>[13]</sup>，这一地层位于山地谷壁的最上部。1826年德雷克将辛辛那提山顶附近的区域描述为“裸露的垂直悬崖”，在费尔维尤组石灰岩的上部因采石活动而变成垂直地形（图4）。包括砍伐森林和采石活动在内的早期土地利用导致辛辛那提发生大规模的山体滑坡<sup>[14-15]</sup>。

在19世纪最后1/3的时间里，斜坡铁路、有轨电车和铁路线的出现使得大量当地人能够“逃离肮脏而拥挤的盆地”而住在远离工厂的区域<sup>[2]</sup>。从19世纪70年代开始，共5条斜坡铁路在市中心盆地周边的各山地上建成（图4）。这些斜坡铁路装载着旅客、建材和货物穿过陡坡，其规模是马车所无法匹敌的。诸如亚当斯山、奥本山、克利夫顿山和普莱斯山这样的新社区得以在山地周围乃至以外地区发展起来。

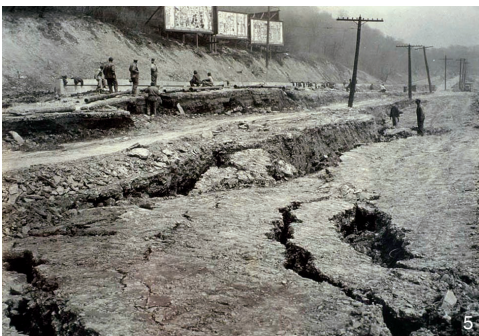
5 哥伦比亚林荫大道工程所导致的 1930 年滑坡  
Landslide in 1930 resulting from development of  
Columbia Parkway

· 1930年，在哥伦比亚林荫大道的施工时发生了一起重大滑坡，原因是在拓宽狭窄的哥伦比亚路时开挖了路面以上的山地，并将土方倾倒下去。哥伦比亚林荫大道自竣工以来持续发生山体滑坡。它是一条主干道，每天承载成千上万的车辆。每年林荫大道上方过陡的斜坡都会冲破挡土墙。这些山体滑坡有时严重到每次足以使部分（或全部）的

东西向交通要道关闭数小时（图5）。

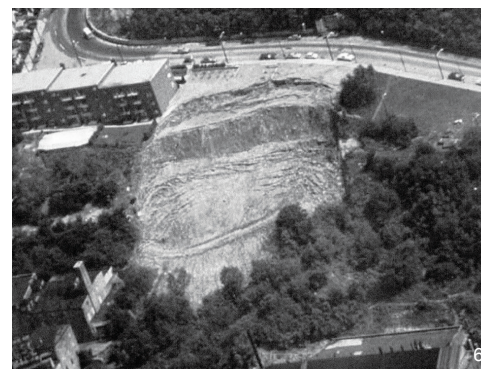
6 1972 年克利夫顿高地滑坡，描绘了滑坡的巨大体积  
Clifton Heights landslide in 1972, depicting the shear volume of hillside that failed

· 1972年，一起大规模山地滑坡在盆地正北方的克利夫顿高地形成了一个55m长、9m高的悬崖，起因是几年前建造的一座公寓楼及毗邻的停车场（图6）。大约12个公寓单元、1座加油站以及滑坡下方工厂的相关人员被撤离<sup>[18]</sup>。至今，从卡鲁塔楼——市中心最高的建筑之一——还可以看到该滑坡的左右两侧。

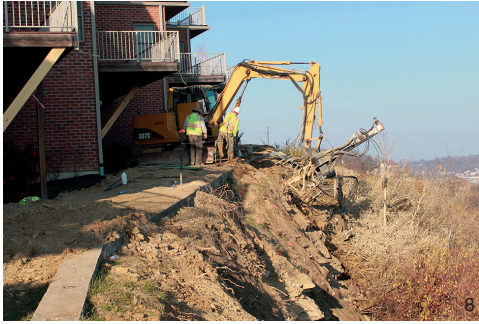
8 2012 年普赖斯山某区域的修复工作，该区域在邻近盆地西边公寓的位置发生严重塌方  
Remediation work on a hillside in 2012 that collapsed perilously close to condominiums west of the basin in Price Hill

虽然之前的 EQ-HS 分区是朝正确方向迈出的一步，但它并非万无一失。据传闻，在 2003 年 EQ-HS 管控下获批的私人山地开发项目中，至少有一个于 2012 年发生了大面积坍塌，导致花费了几十万美元的维修费用（图 8）。幸运的是，公寓业主可以根据俄亥俄州关于开发商责任的 10 年时效法规起诉开发商。山地信托基金会在分区审批过程中曾公开评论过这一案件。当灾难发生时，基金会发现其建议中至少有一条未被开发商采纳，就是建筑应该远离山脊线。到目前为止，由当前 HOD 分区下批准的开发项目尚未发生崩塌问题。

While the former EQ-HS zoning was a step in the right direction, it was not fool-proof. Anecdotally, at least one private hillside development approved under the former EQ-HS in 2003, failed in 2012 when a massive section of hillside collapsed, resulting in a repair bill in the hundreds of thousands of dollars (see Figure 8). Fortunately, condominium owners were able to sue the developer under the State of Ohio's 10-year statute of limitations pertaining to developer liability. The Hillside Trust had publicly commented on this case during the zoning approval process. When the failure occurred, it discovered at least one of its recommendations, siting the building further away from the brow of the hill, was not followed by the developer. To date, no known slope failures have occurred involving development projects approved under the current HOD zoning.
